## **Geophysical Surveys for Detecting Anomalous Conditions, Algiers Canal Levees, New Orleans, Louisiana**

José L. Llopis and Joseph B. Dunbar

August 2014

Final report

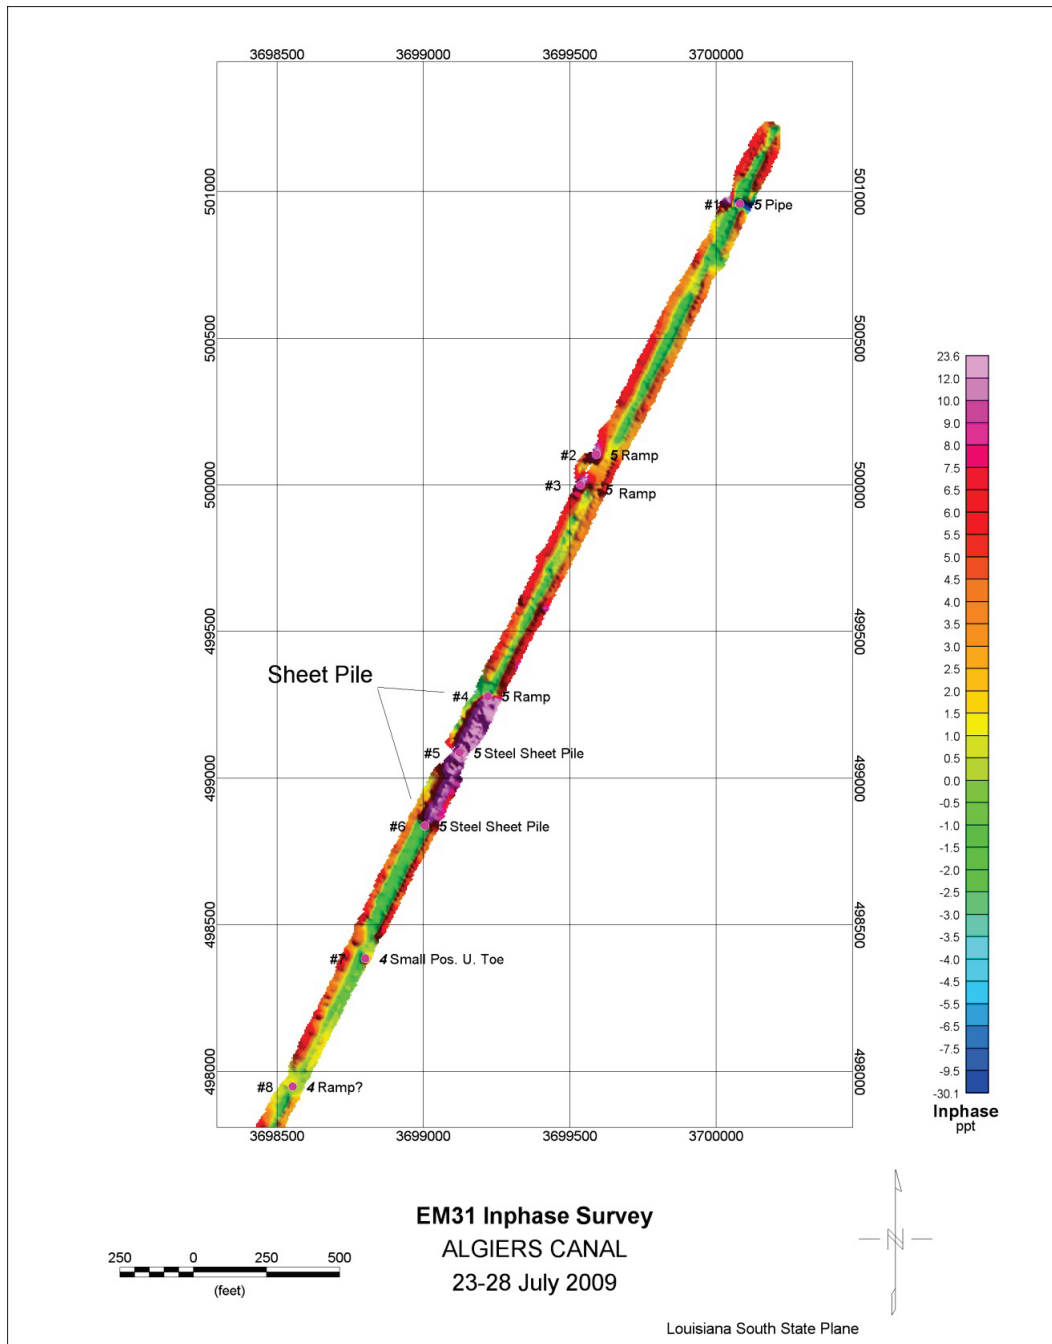
Figure A1. EM31 in-phase survey results, Section 1.

section. The highest priority given to an anomaly in this section was a priority of 4. A steel sheet pile, located between approximate stations 1001+81 and 1006+78, is clearly evident (hot pink area). With the exception of the area in the vicinity of the steel sheet pile, the values along the center line of the levee are fairly consistent indicating very little or no metallic debris within the levee. However, the values along the toes of the levee have considerable variability. This variability is mainly caused by the effects of nearby metallic objects (e.g., cranes, metal buildings, pipes, reinforced concrete slabs). The anomalies along the toes are not considered to be a threat to the integrity of the levee and thus are not noted.

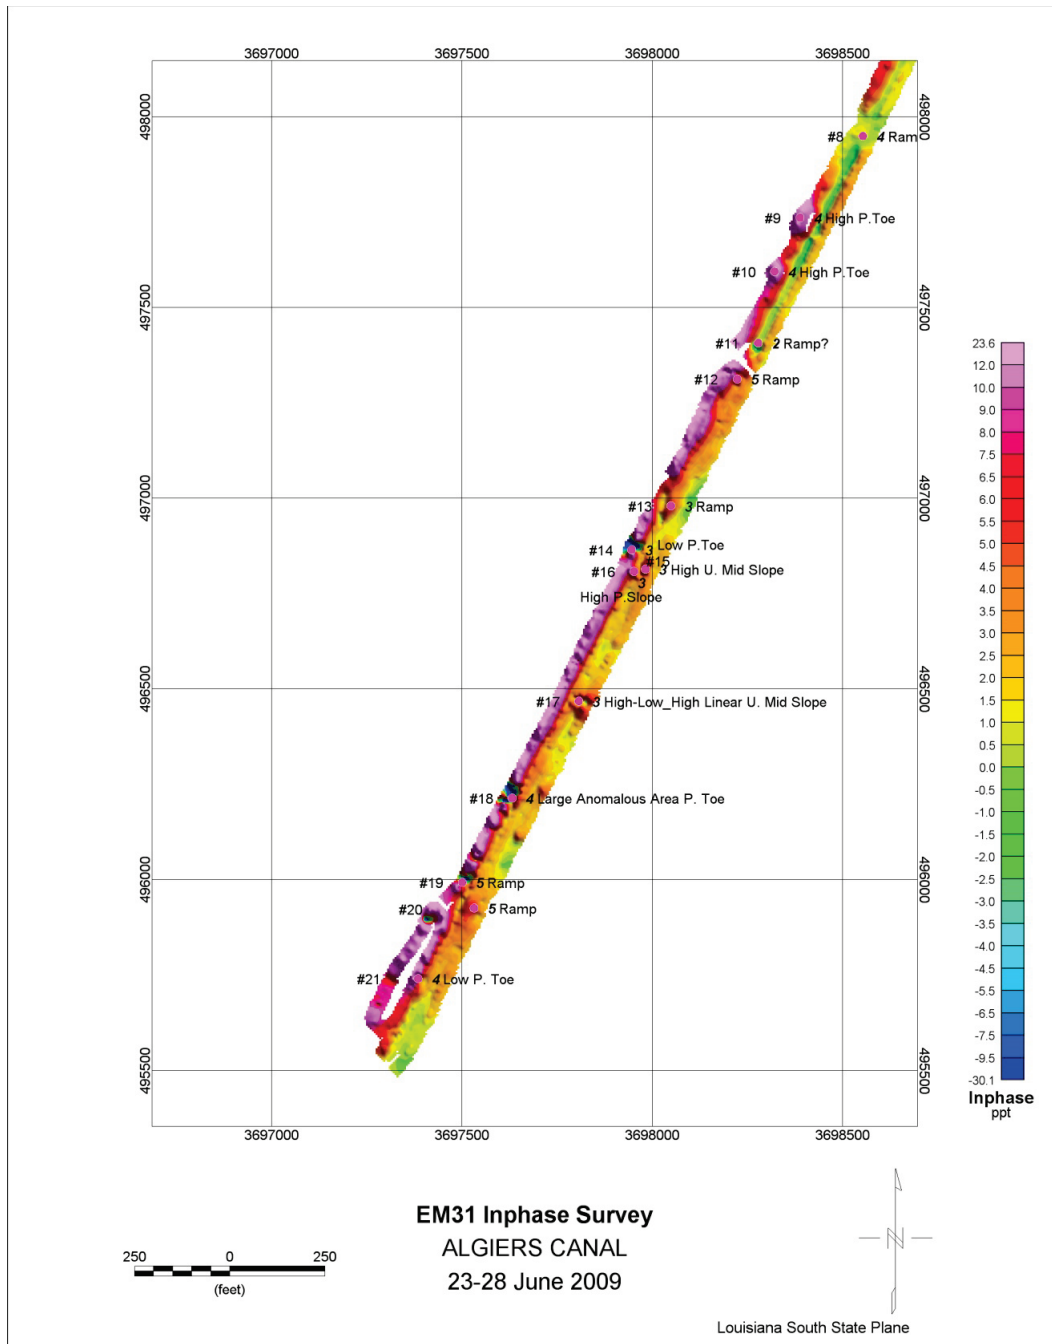
Figure A2. EM31 in-phase survey results, Section 2.

Section 2 continues in a southeasterly direction between approximate stations 1018+21 and 1044+18. The results are shown in Figure 6. A priority 2 anomaly is indicated for anomaly #11 at approximate station 1022+90 and may be caused by a small buried metallic object. A cluster of priority 3 anomalies (anomalies #14, #15, and #16) are shown near station 1029+48.

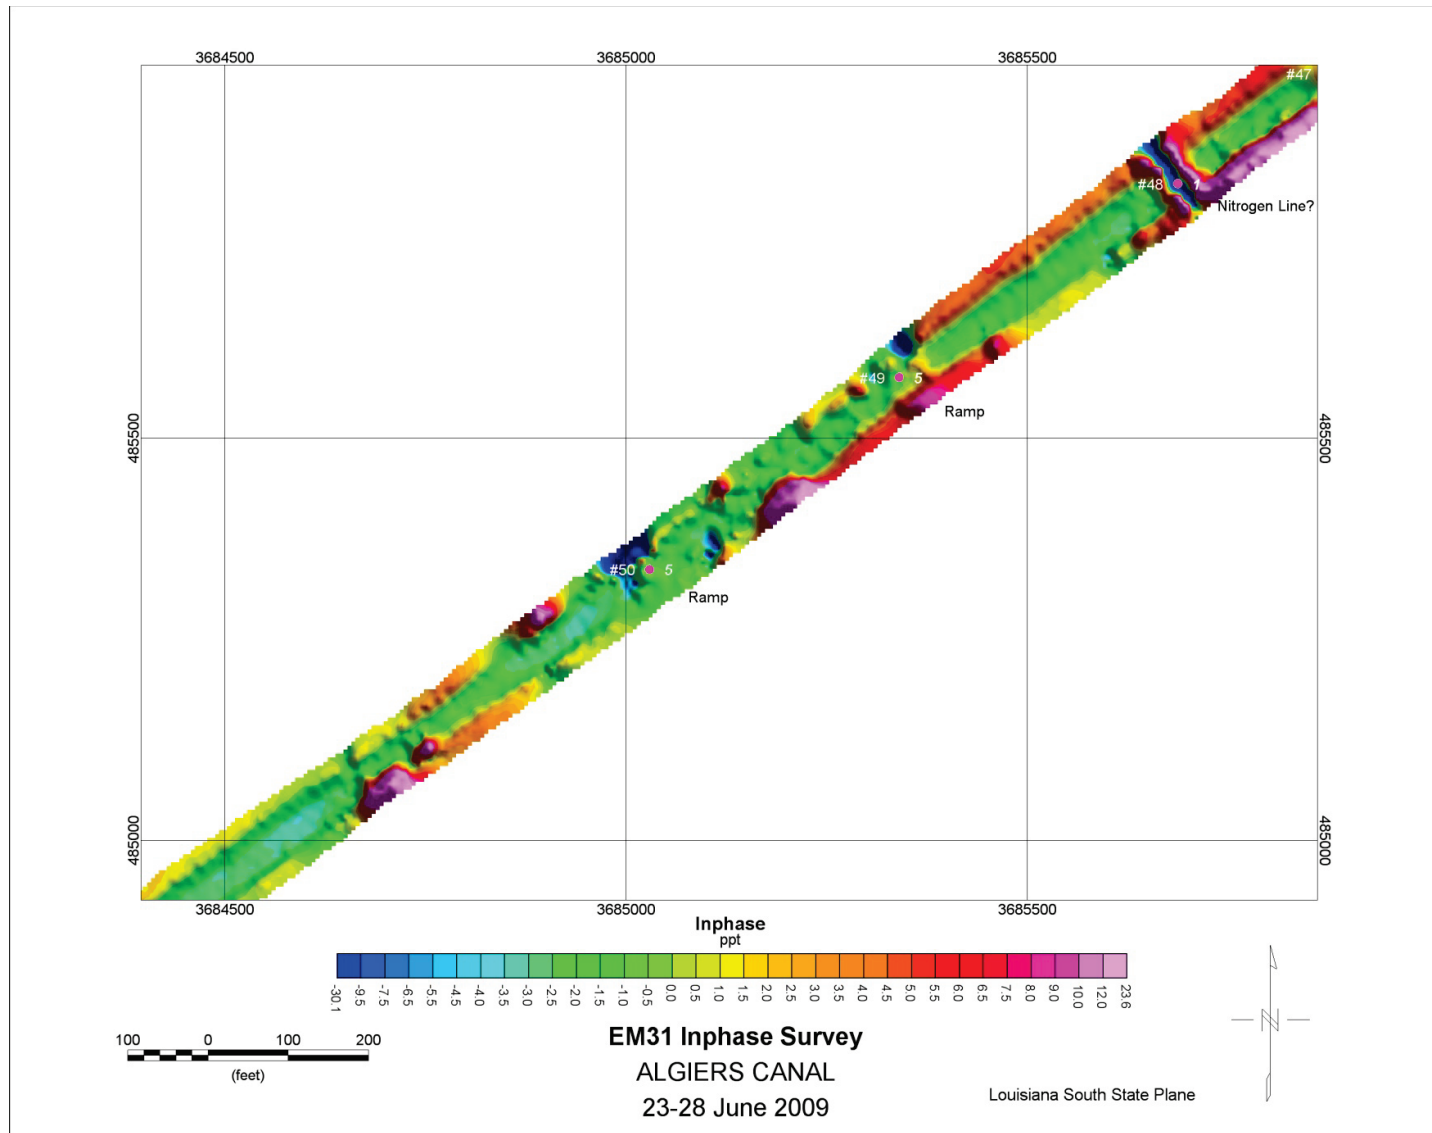
Figure A7. EM31 in-phase survey results, Section 7.

Section 7 is located between approximate stations 1194+31 and 1211+26. Three anomalies were interpreted for this section as shown in Figure 11. Anomaly 48, located at station 1196+64, is a strong linear-shaped anomaly that crosses the levee. A hump crosses the levee center line directly over the location of the anomaly. It is presumed that this anomaly is caused by a buried nitrogen line indicated in the construction drawings.

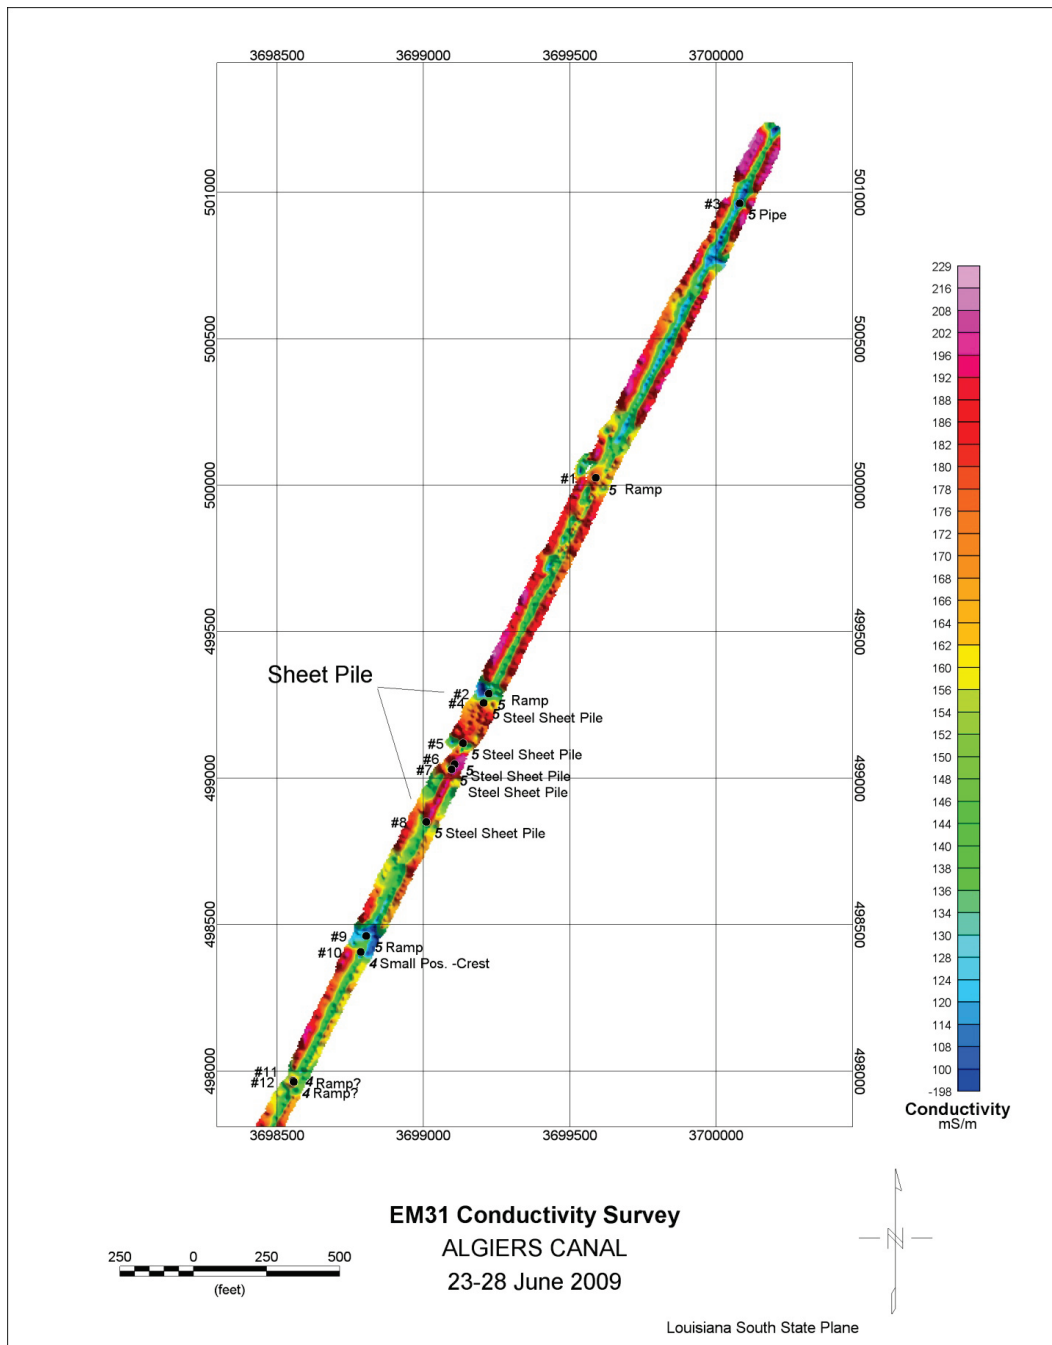
Figure B1. EM31 conductivity survey results, Section 1.

Section 1 extends from the Highway 23 tunnel (station 980+00) southwesterly to approximate station 1018+21. The survey results for Section 1 are presented in Figure 13. No priority 1 or 2 anomalies were interpreted for this section. The highest priority given to an anomaly in this section was a priority of 4. As was the case for the in-phase survey, a steel sheet pile, located between approximate stations 1001+81 and 1006+78, is clearly evident. It is again noted, with the exception of the area in the vicinity of the steel sheet pile, that the values along the center line of the levee are fairly consistent indicating little or no metallic debris within the levee.

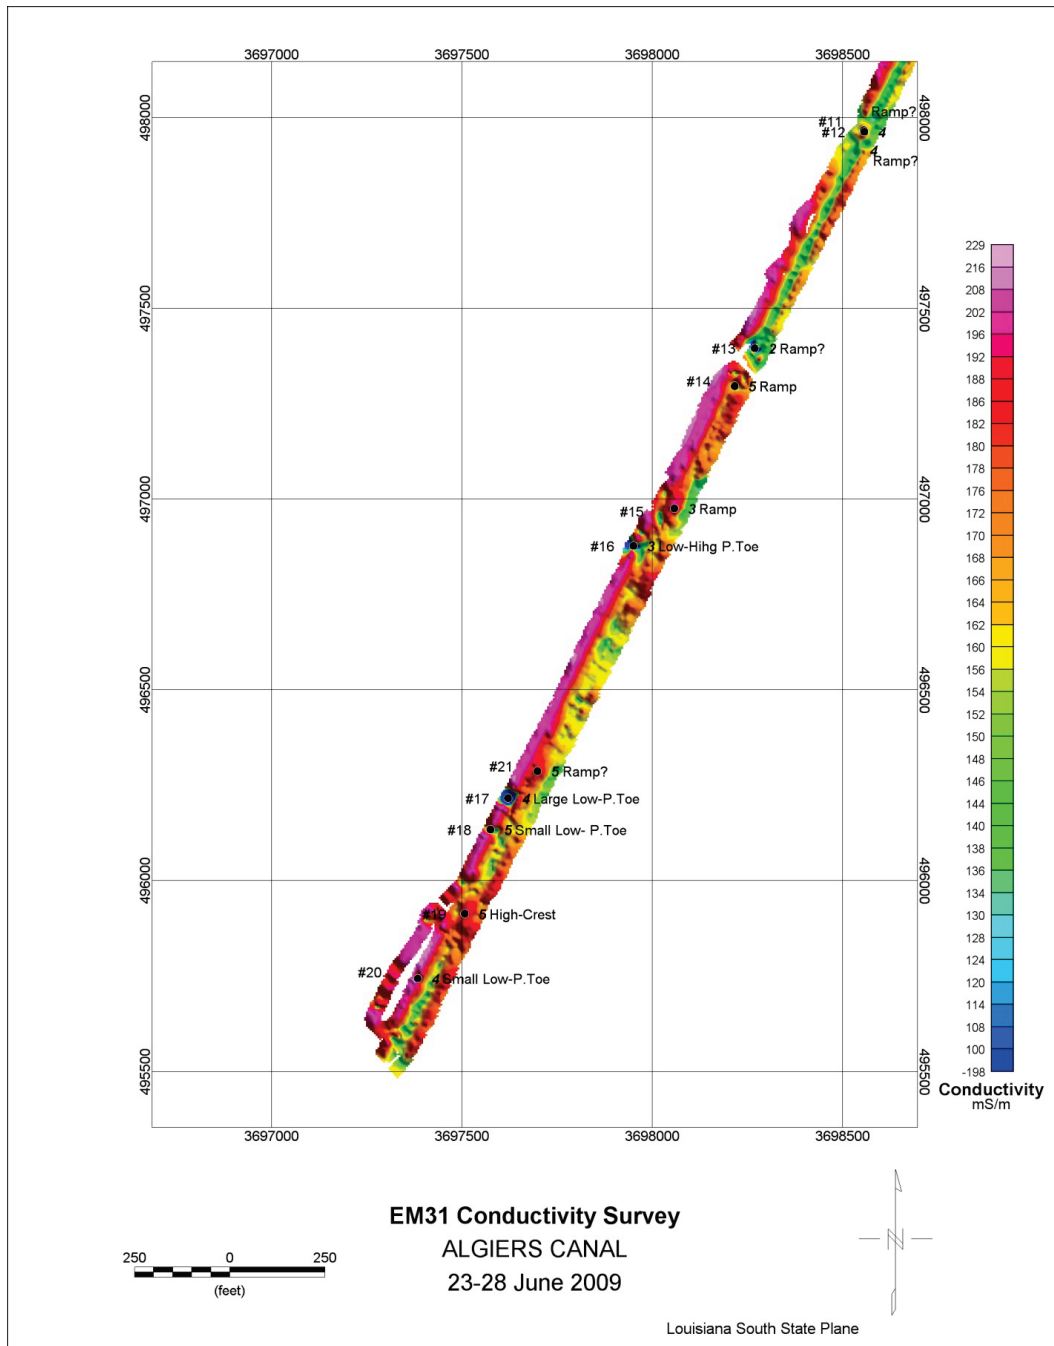
Figure B2. EM31 conductivity survey results, Section 2.

Section 2 continues in a southeasterly direction between approximate stations 1018+21 and 1044+18. The results are shown in Figure 14. A priority 2 anomaly is indicated for anomaly 13 at approximate station 1023+02 and may be caused by a small buried metallic object.

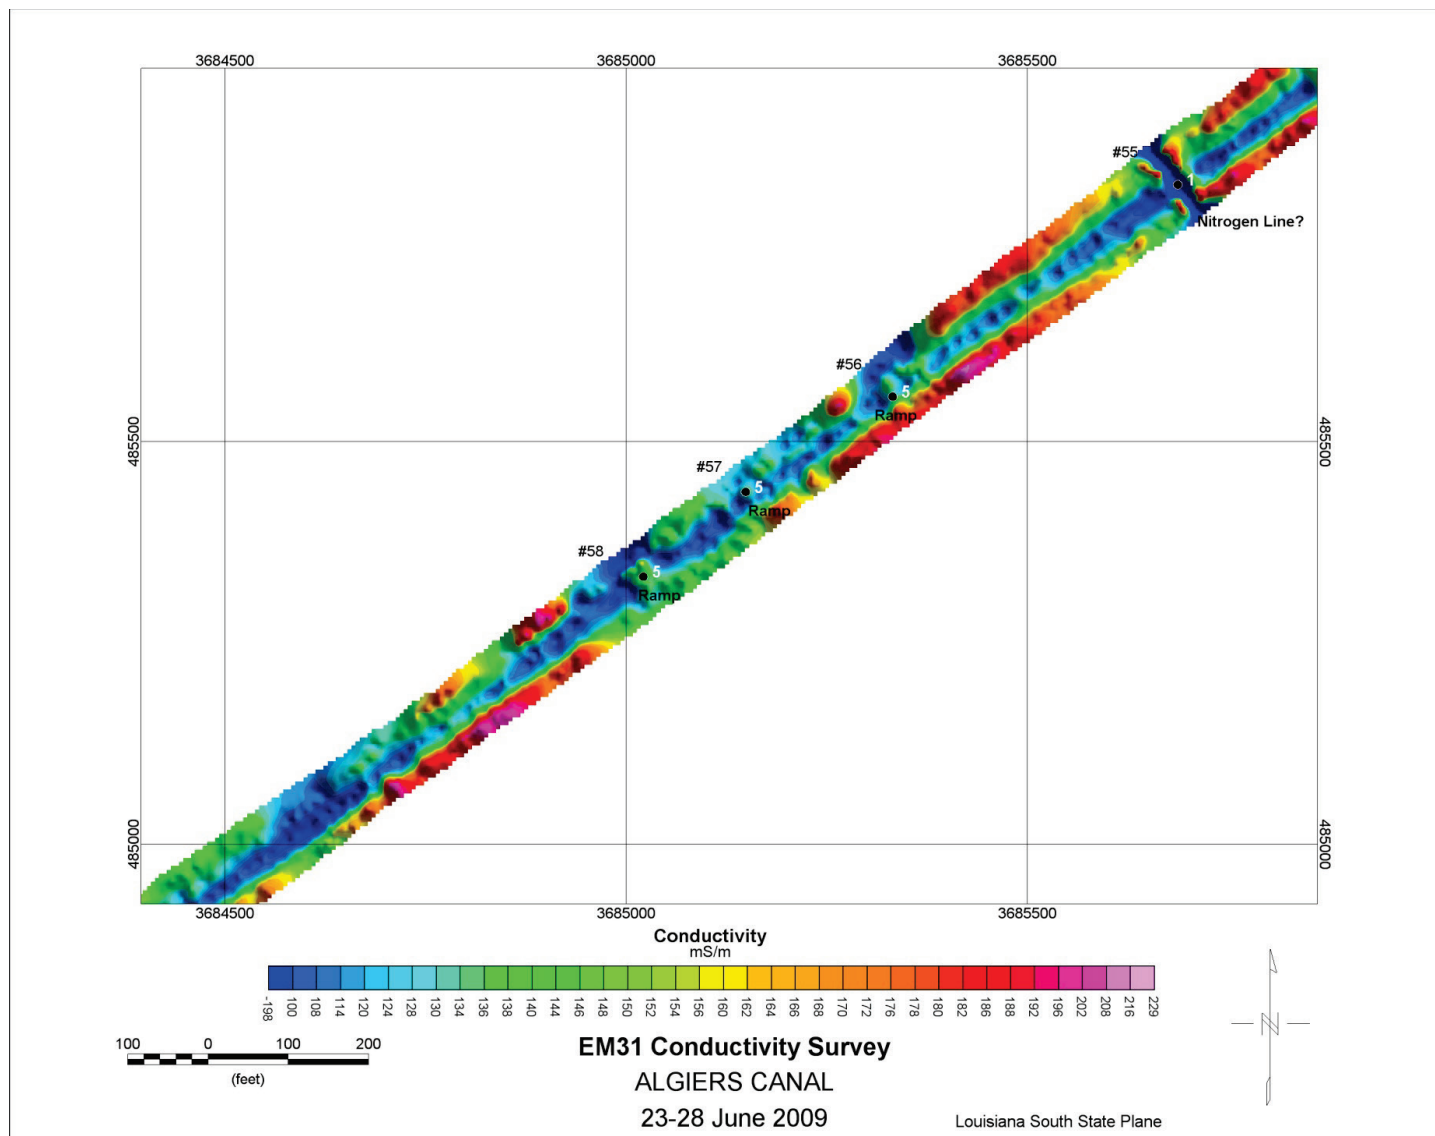
Figure B7. EM31 conductivity survey results, Section 7.

Section 7 extends between approximate stations 1194+31 and 1211+26 (Figure 19). Four anomalies, one a priority 1 and the remaining three priority 5 anomalies, were interpreted for this section. Anomaly 55, a priority 1 anomaly, is located at station 1196+63, and is a strong linear-shaped anomaly that crosses the levee. There is a hump in the levee center line directly over the location of the anomaly. It is presumed that this anomaly is caused by a buried nitrogen line indicated in the construction drawings. The remaining anomalies coincide with the locations of ramps.
